Draft Report - February, 2013

EXTERIOR BUILDING ENCLOSURE EVALUATION

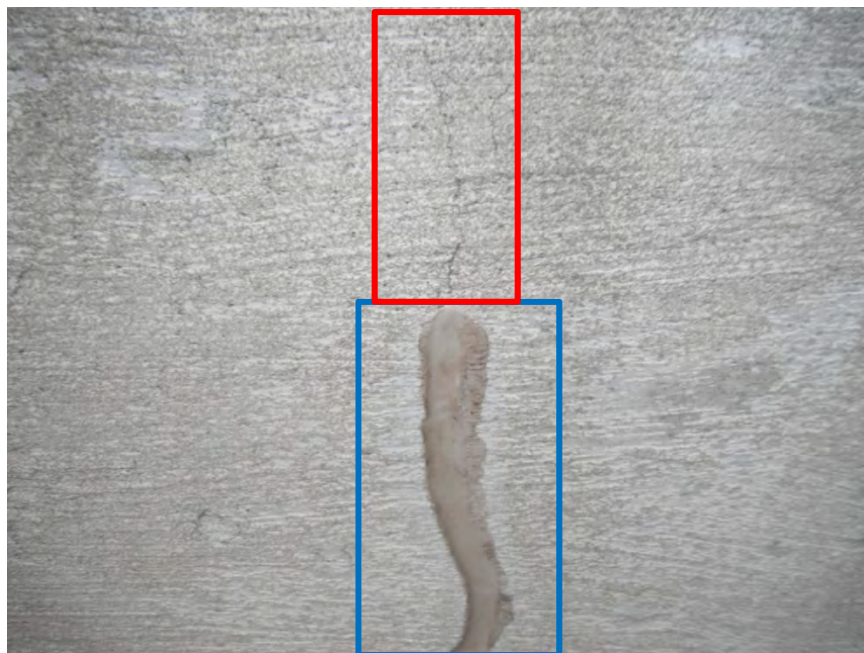
Photo 6: Typical example of concrete cladding panel where a crack has previously been partially sealed. The sealed portion of this crack is highlighted with a blue box, while the unsealed portion is highlighted with a red box.

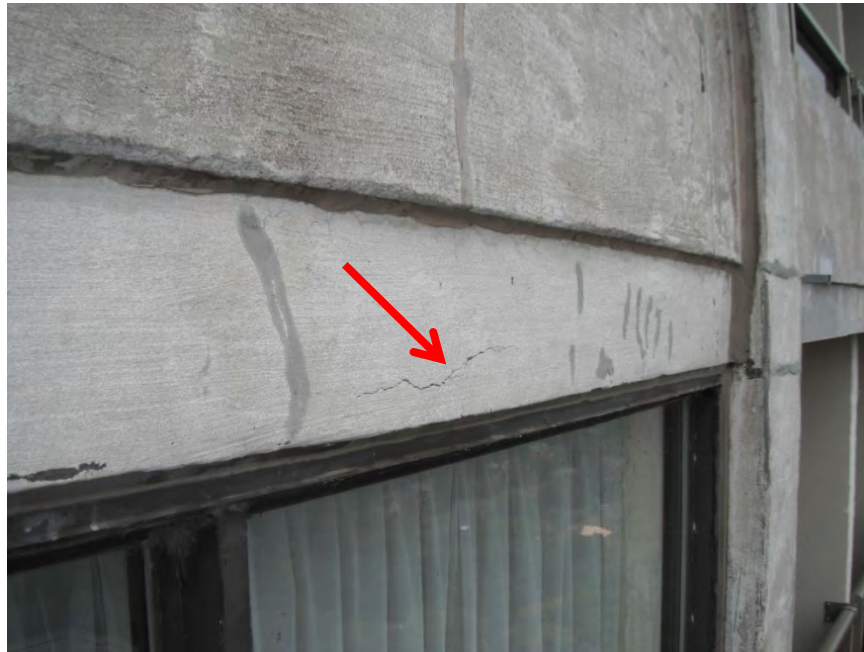
Photo 7: An example of a fractured concrete floor slab above a window location (red arrow).

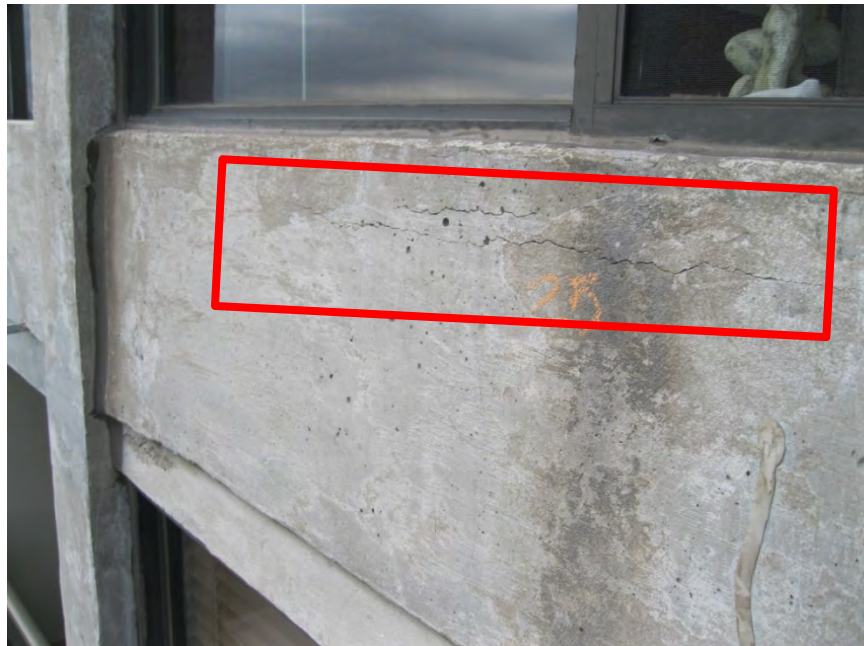
Photo 8: An example of a fractured and delaminated concrete (red box) at a concrete cladding panel below a window.

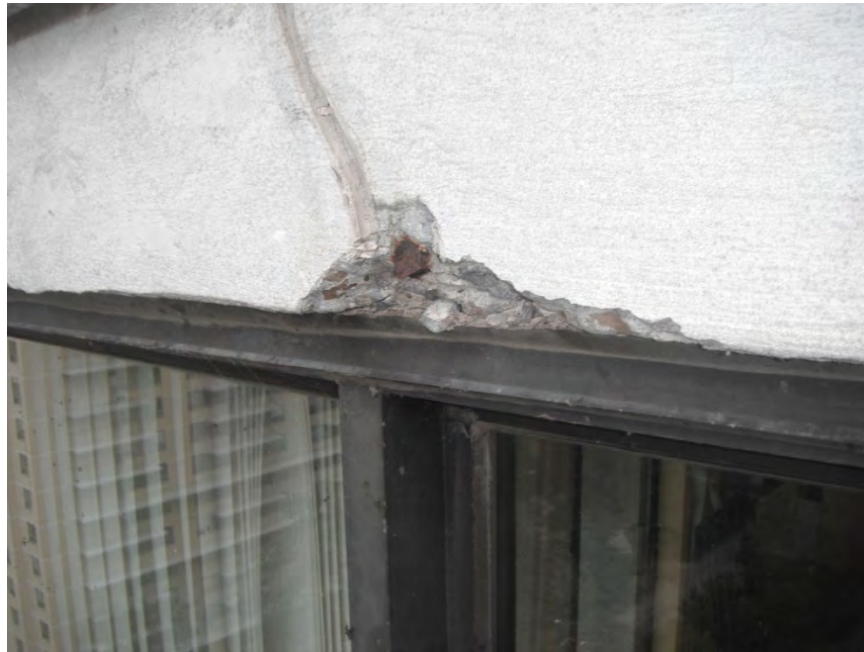
Photo 9: An example of a concrete spall due to corrosion of reinforcing steel in exposed concrete floor slabs.

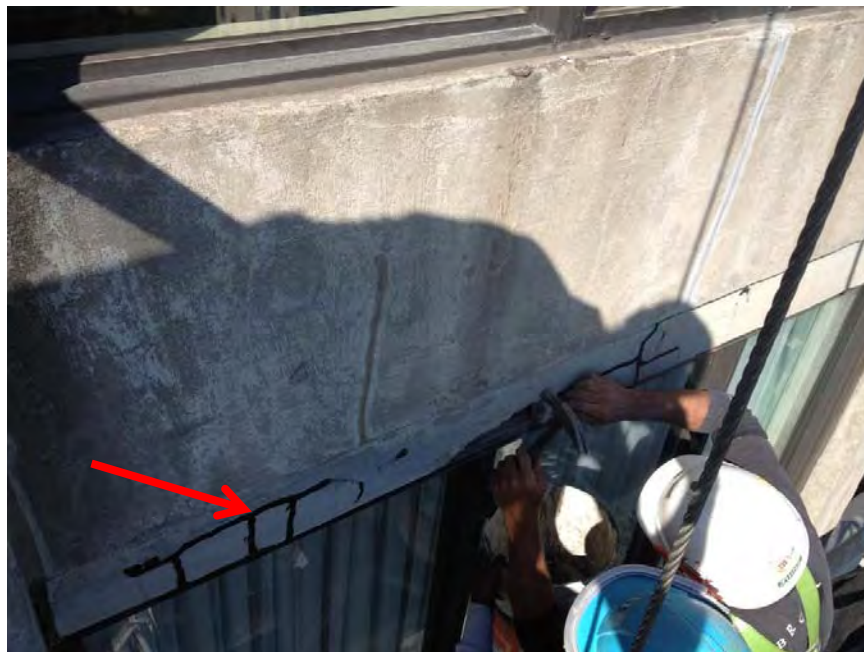
Photo 10: Photo of concrete repair work under way. Concrete fractures have been previously sealed over using brown sealant (red arrow). Brook is completing a repair at a previously sealed location.

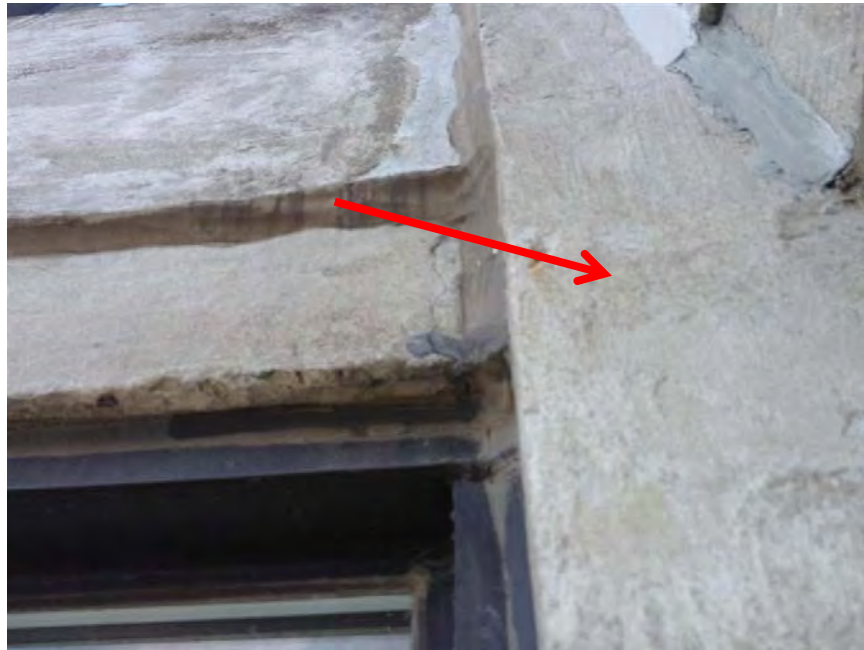
Photo 11: An example of a wall to floor slab construction joint is identified with a red arrow.

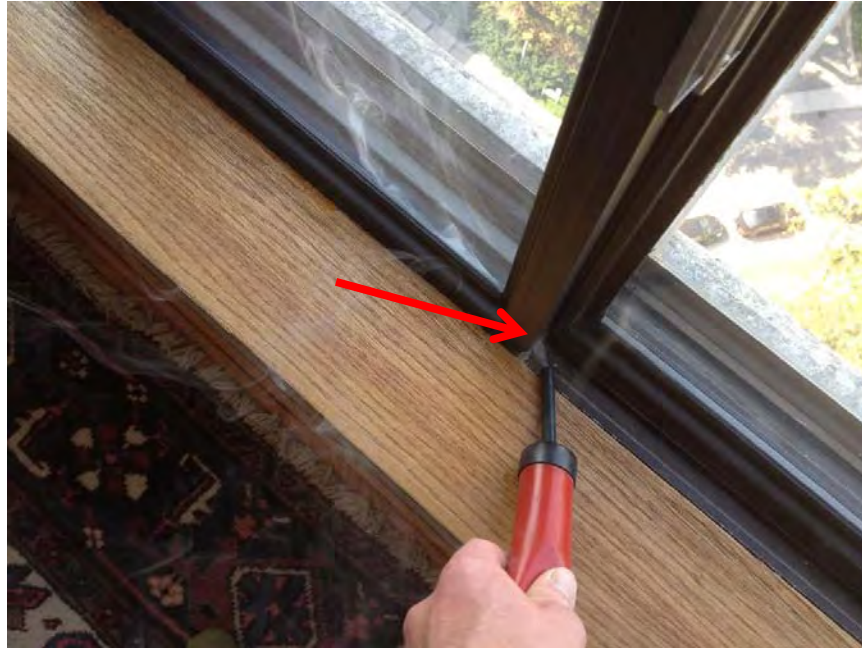
Photo 13: Using a smoke pencil, we noted widespread air leakage at operable windows – note the smoke travelling through the closed operable window at the bottom of the meeting style (red arrow).

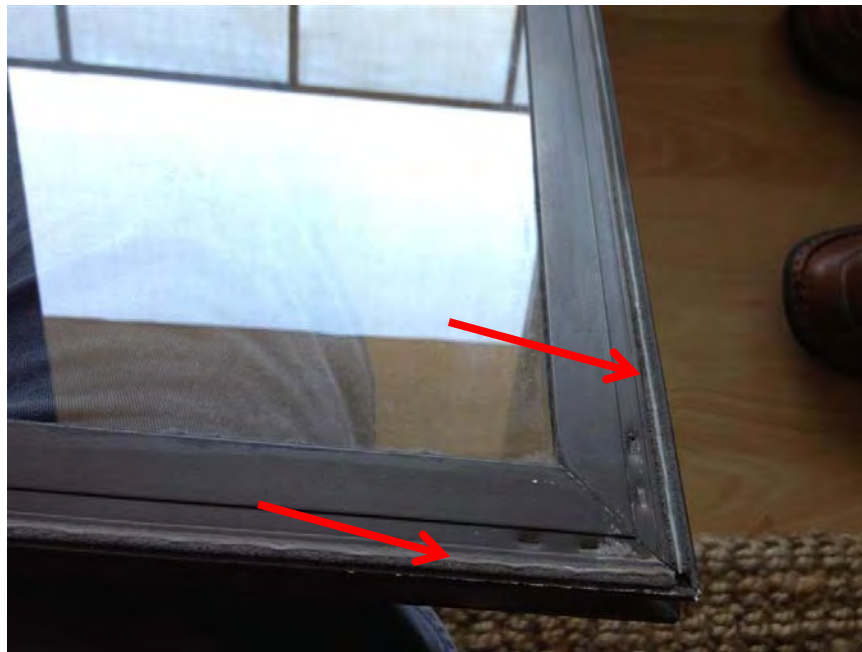
Photo 14: Fin type weather stripping at operable windows appeared to be in generally serviceable condition.

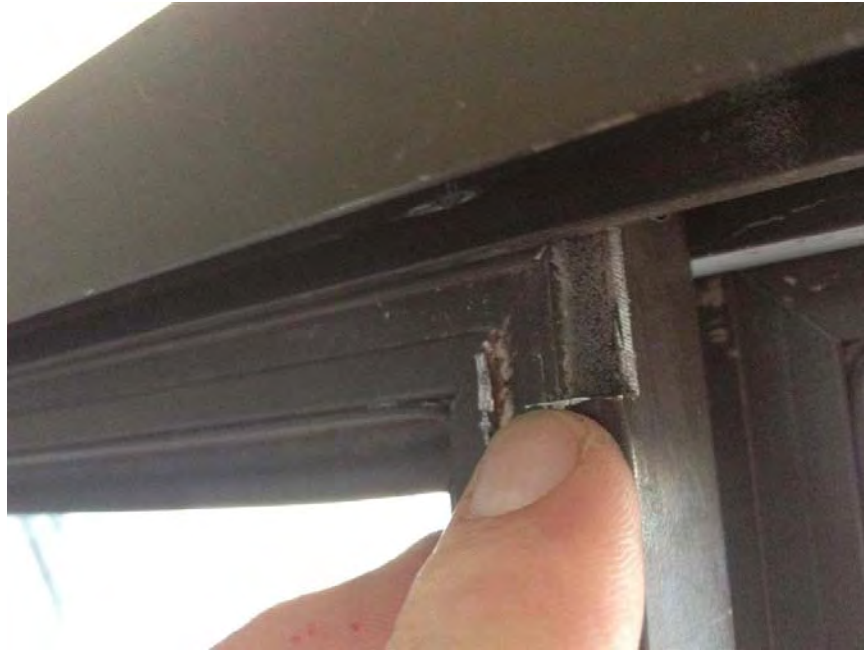
Photo 15: Dust plugs (weather stripping at window corners) are in poor condition.

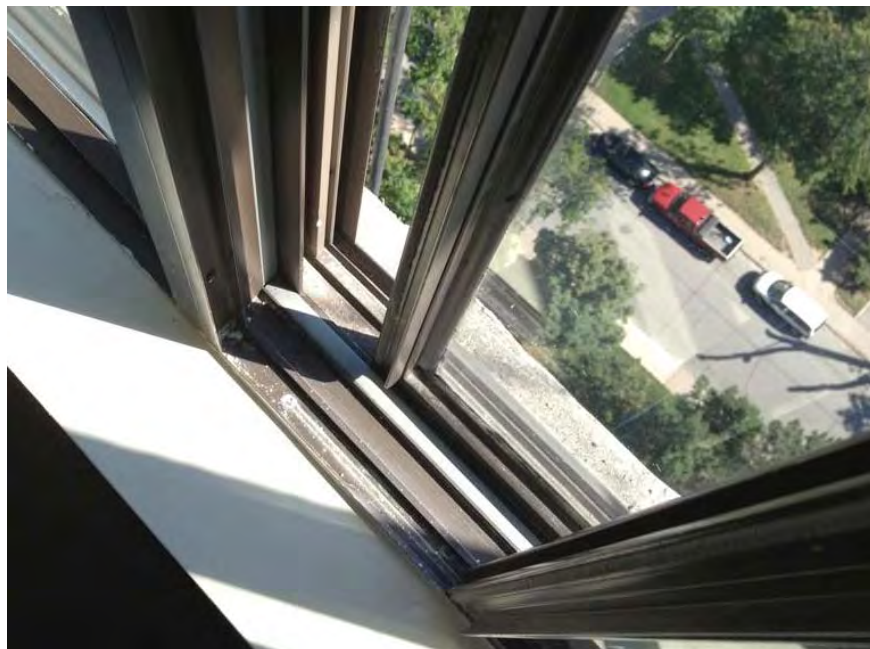
Photo 16: An example of a worn window track; likely a result of worn out rollers.

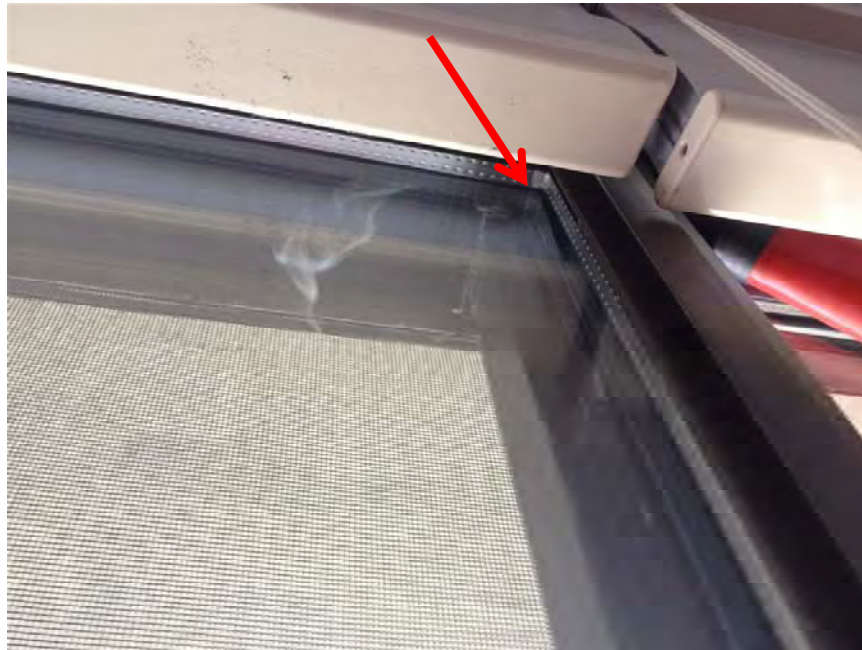
Photo 17: Air leakage was also noted at the top and bottom corners of sliding doors. Note the smoke travelling through the top corner of a closed sliding door (red arrow).

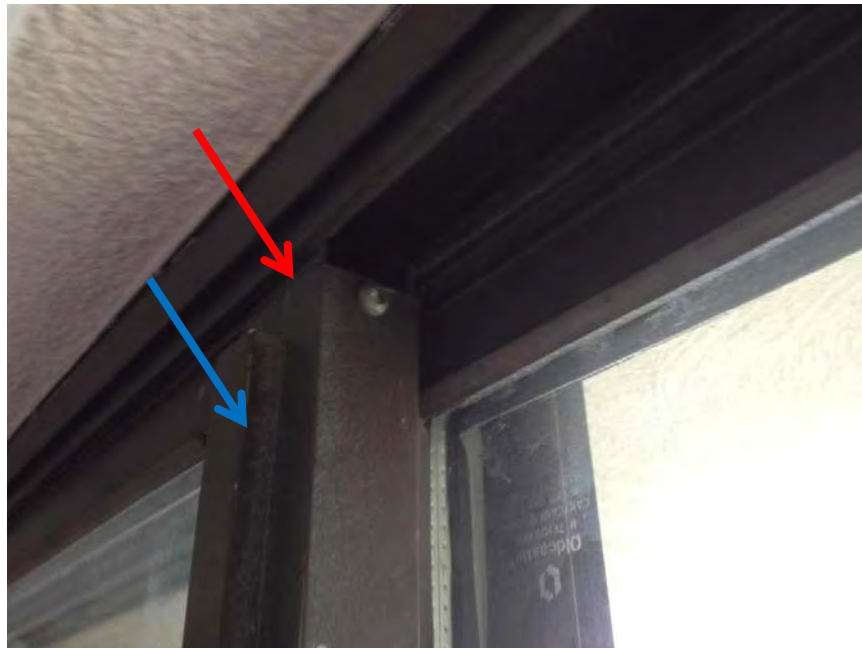
Photo 18: The existing door perimeter and meeting style weather stripping (blue arrow) is in generally poor condition and no dust plugs were present at door corners (red arrow indicates where dust plug should be).

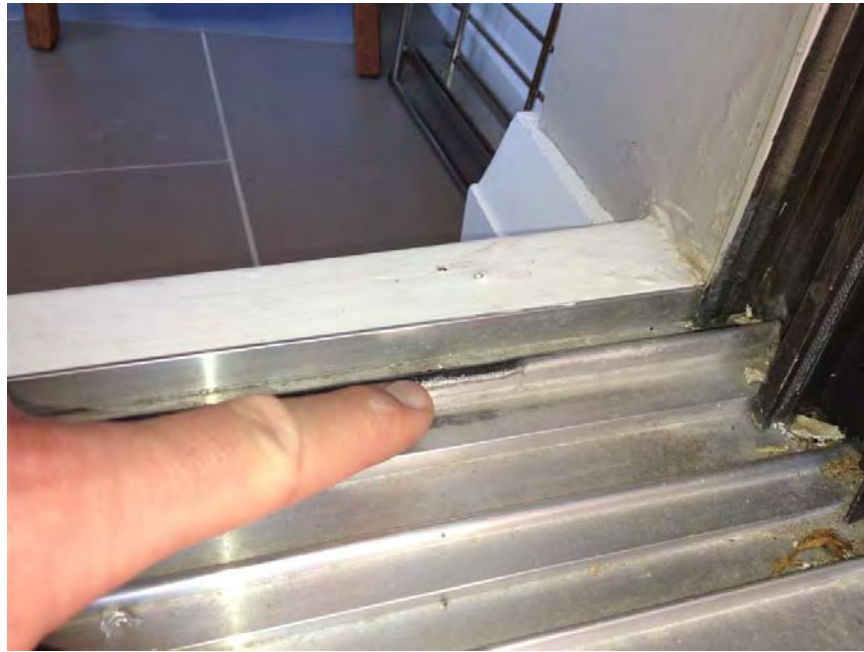
Photo 19: An example of a sliding door track that is severely worn.

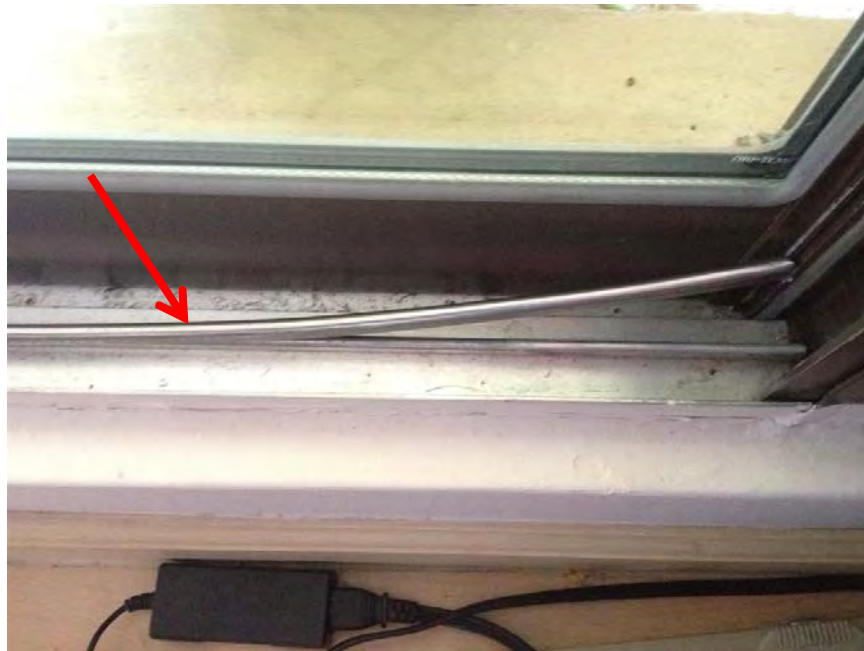
Photo 20: New stainless steel sleeves (red arrow) have been installed at some sliding door locations. In some places, the sleeve has become bent and is no longer functioning as intended, as shown in the photo above.

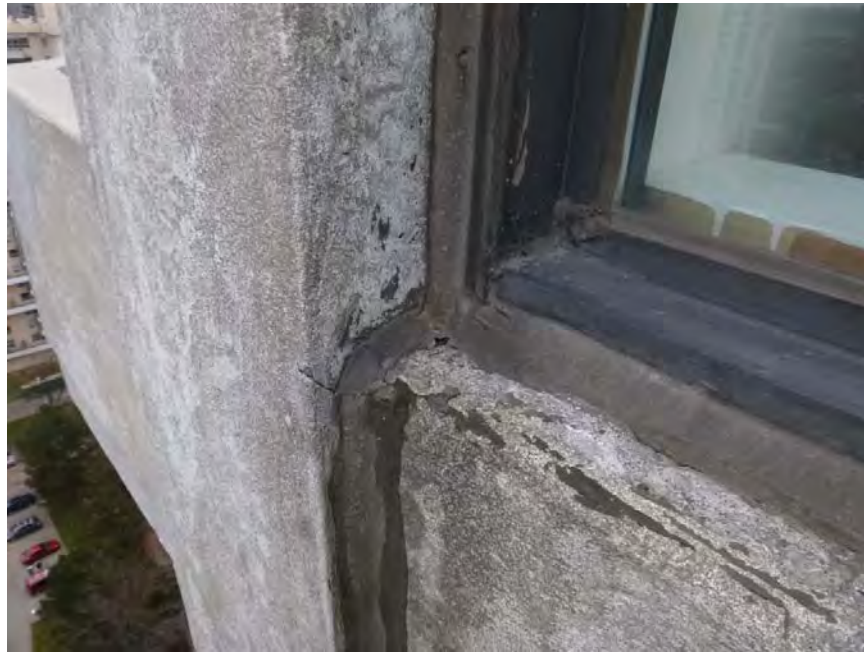
Photo 21: An example of a localized section of debonded window perimeter sealant.

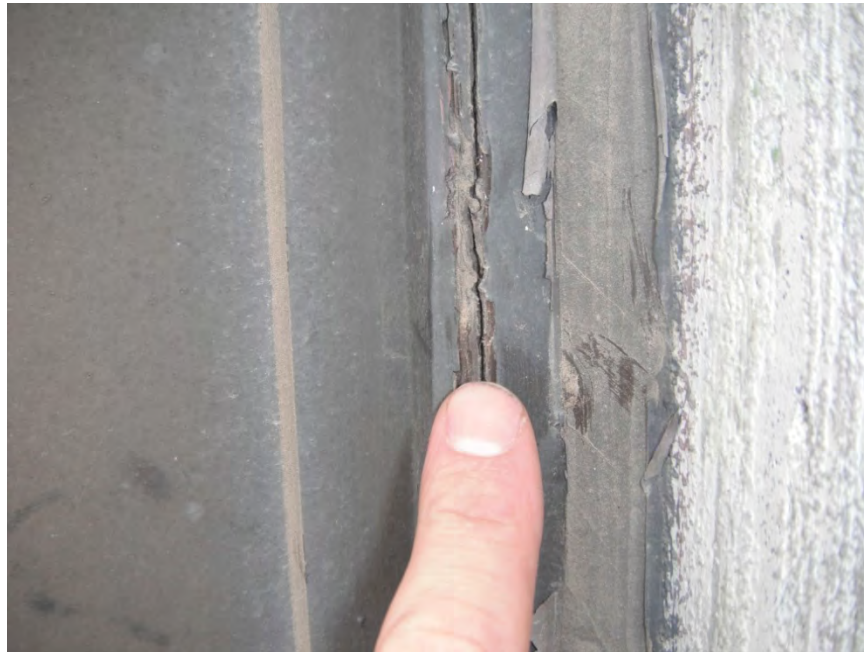
Photo 23: An example of failed metal-to-metal sealant at a window jamb.

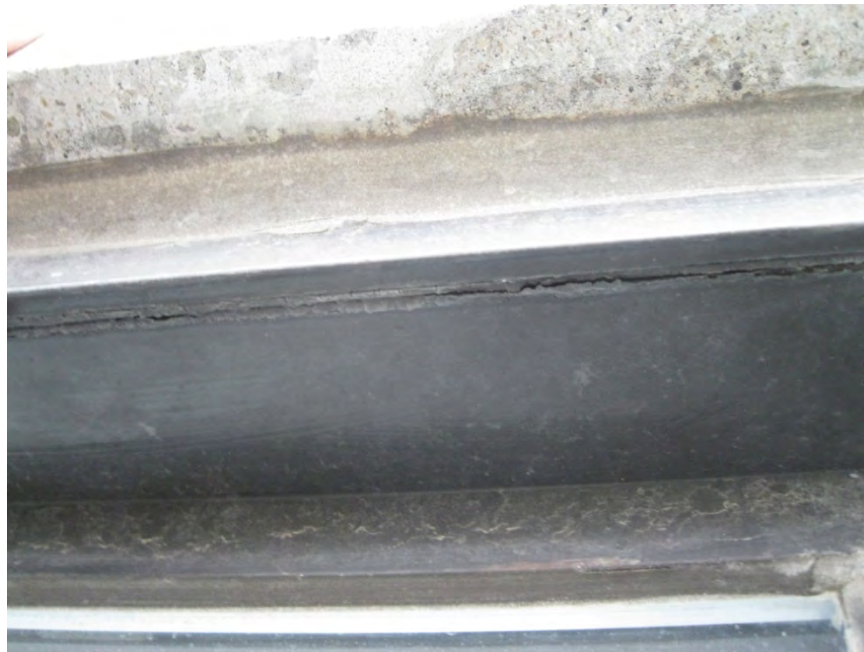
Photo 24: Another example of failed metal-to-metal sealant at a window head.

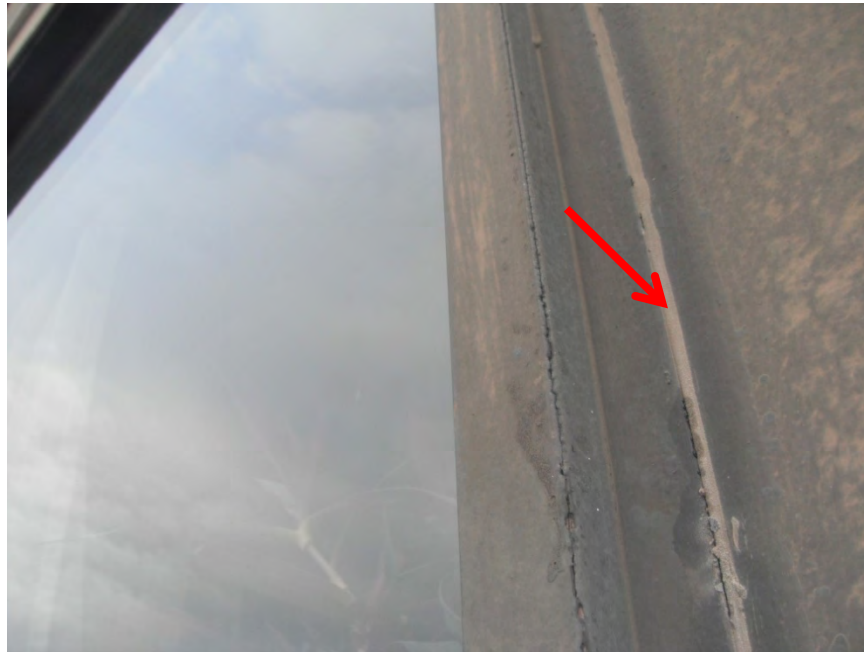
Photo 25: The profile of the needle glazing at metal cladding panels (indicated with red arrow) is generally thin and narrow.

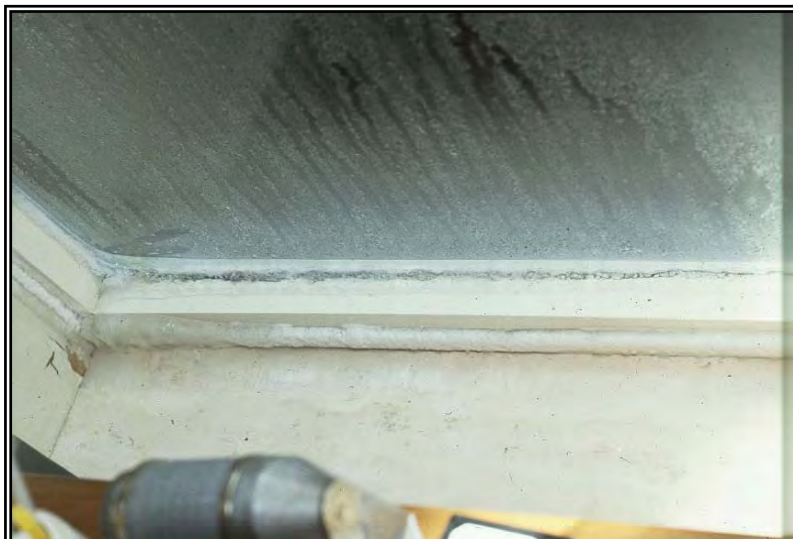
Photo 1.: Example of severe condensation from thermal bridging, excessive humidity and poor heat distribution.

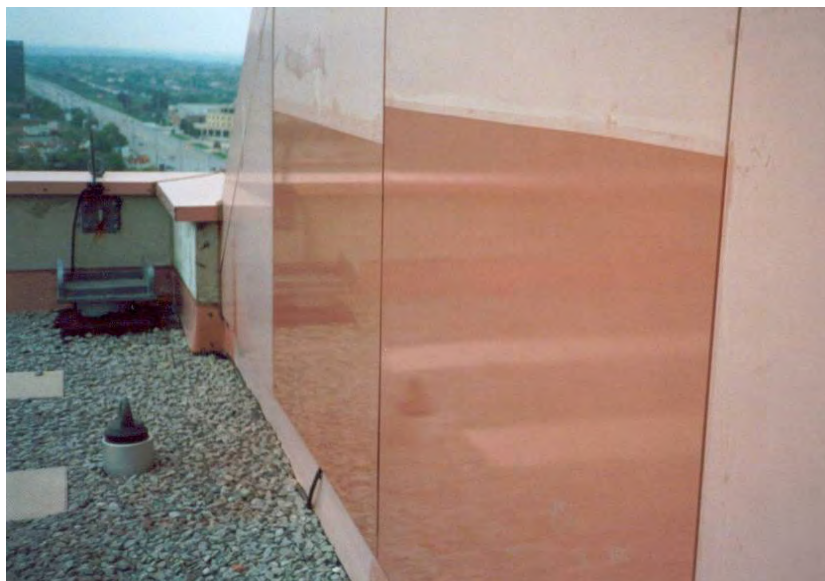
Photo 2.: High performance fluropolymer coatings (“Duronar” by PPG) better resist deterioration with UV exposure. These are expected to provide acceptable performance for more than 30 years.

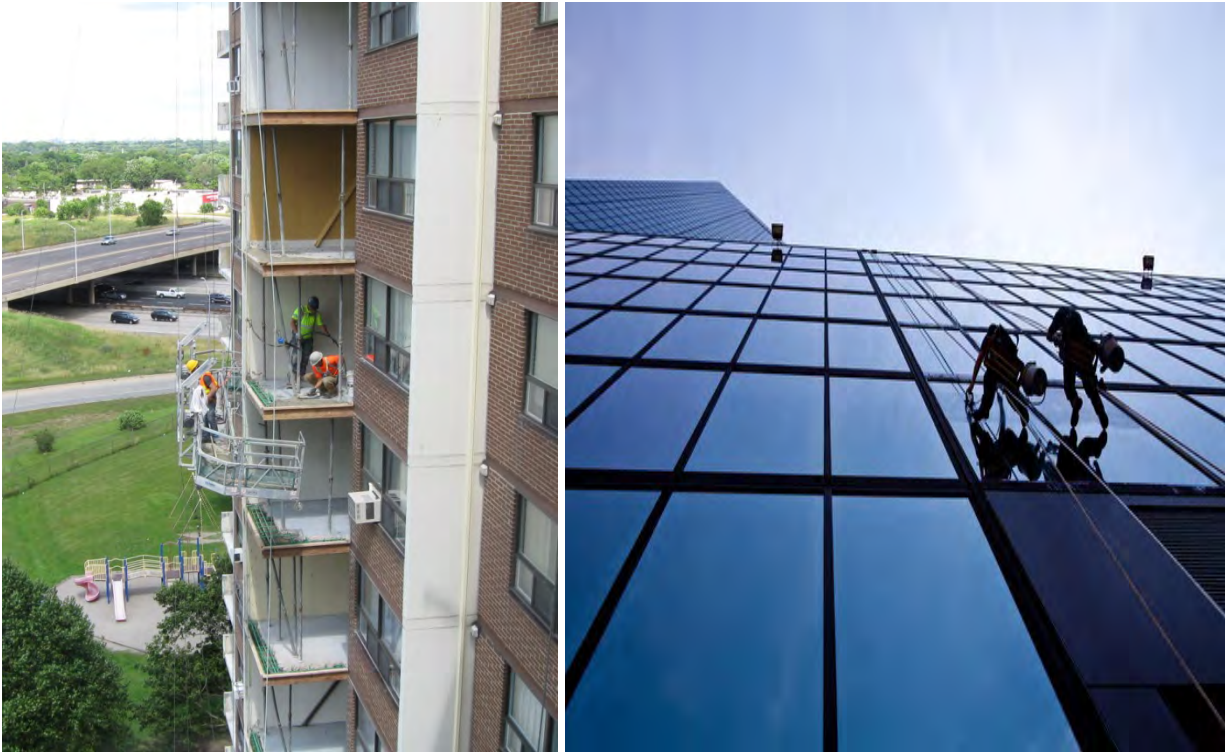
Photo 1.: Suspended Access Equipment – Swing Stage (left) and Bosun's Chair (right)

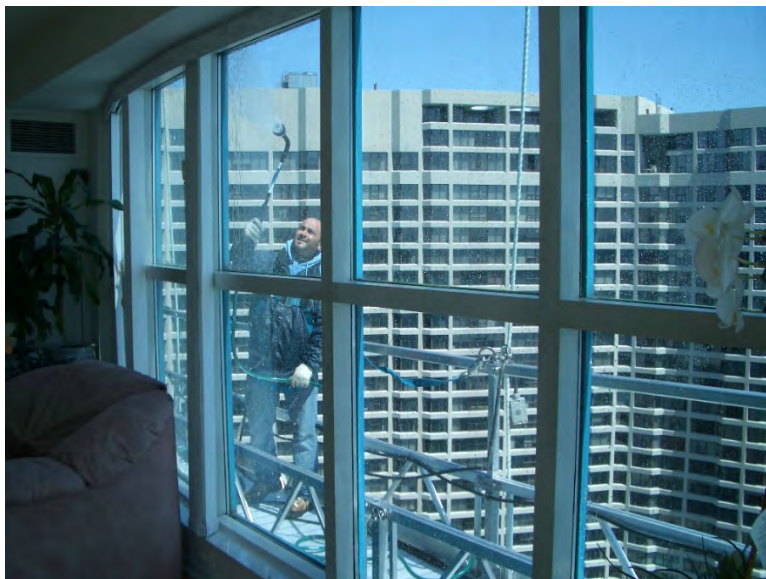
Photo 2.: Example of Water Testing on a Curtain Wall Assembly

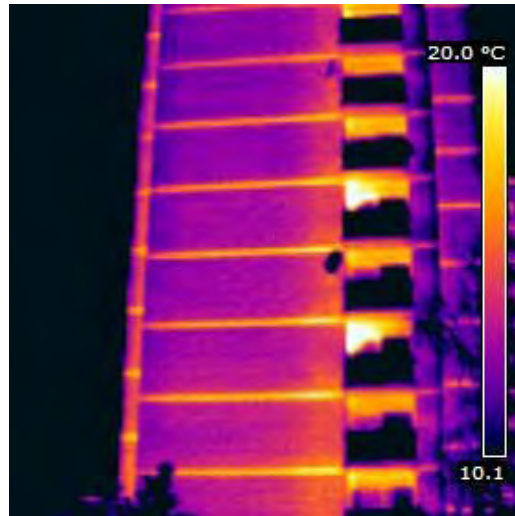
**Photo 3.:** Example Thermal Image - Insulated Masonry Wall with Un-Insulated/Exposed Concrete Floor Slab Edges.

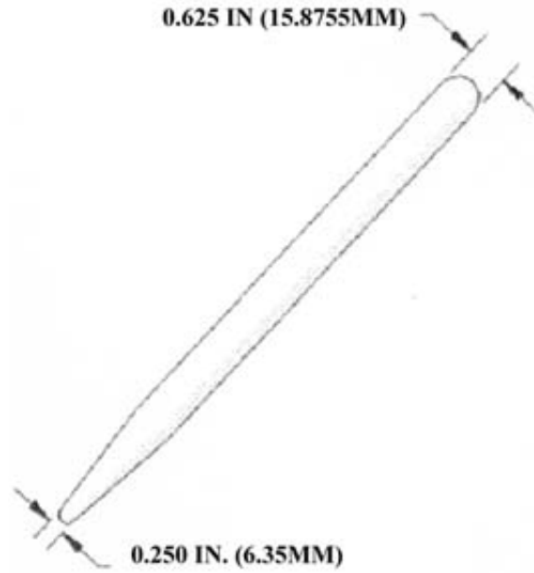
Photo 1.: Probing Tool (Figure from ASTM C1521).

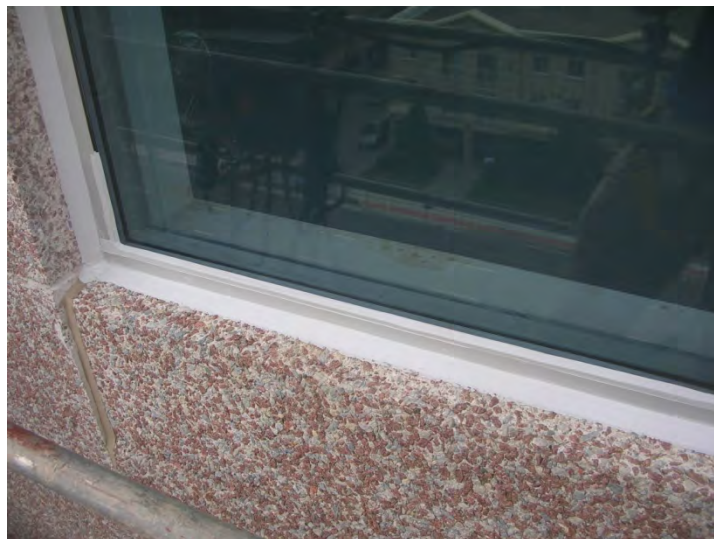
Photo 2: Example of cap seal at glass/metal joint limited to bottom of IGU.
